**Flood Control Project Maintenance
Levee Inspections**
LMA District Cover Sheet
Spring 2018 Levee Inspection Results

Sutter Maintenance Yard Maintenance Area 0003

Waterway			Bank	Unit Miles
Unit No. 01 Feather River			Right	5.11
	Spring (March - May)	Summer (June - August)	(September - November) Fall	Winter (December - February)
Unit Maintenance Rating (Fall Only)				
Date of Inspection	3/22/2018 - 3/22/2018			
DWR Inspector	Sterling York			
Accompanied By	Steve Beckley

Levee Inspection Report By Mile - Spring 2018

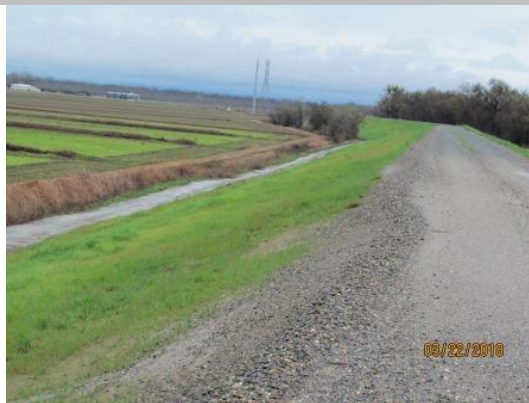
Photo 1 of 1 : SP_2018_MA0003_195_11_20180402_00027.jpg

LM Start	0.01	Rating **	A	Issue No.	11
LM End	5.11	Issue Type +	Ma	Location *	LS
Category	Earthen Levee			GPS Latitude/Longitude	
				Start	End
Item	Vegetation			38.898052 °	38.950950 °
				-121.617932 °	-121.585779 °
DWR ID	DWR_MA0003_01_s_2018_11				
Comment Code					
V1 : Control annual grass and weeds on the levee slopes and easements.					
Inspector Comment					
Annual vegetation is well maintained, Spring 2018.

View looking upstream landside of the well maintained vegetation, Spring, 2018.

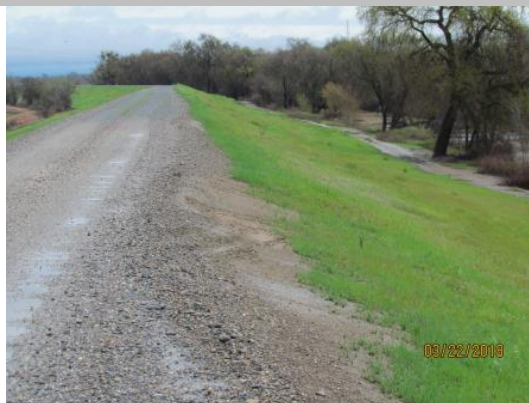
Photo 1 of 1 : SP_2018_MA0003_195_12_20180402_00028.jpg

LM Start	0.01	Rating **	A	Issue No.	12
LM End	5.11	Issue Type +	Ma	Location *	WS
Category	Earthen Levee			GPS Latitude/Longitude	
				Start	End
Item	Vegetation			38.898051 °	38.950950 °
				-121.617931 °	-121.585779 °
DWR ID	DWR_MA0003_01_s_2018_12				
Comment Code					
V1 : Control annual grass and weeds on the levee slopes and easements.					
Inspector Comment					
Annual vegetation is well maintained, Spring 2018.

View looking upstream waterside of the well maintained vegetation, Spring, 2018.

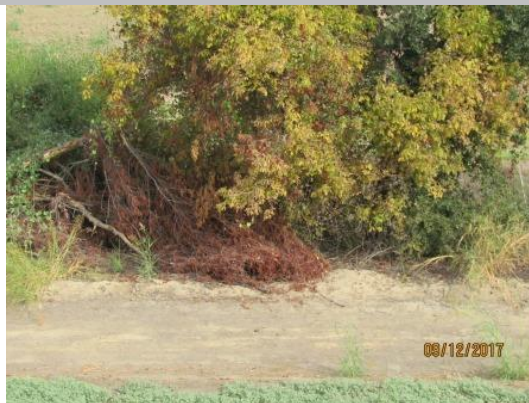
Photo 1 of 3 : SP_2018_MA0003_195_17_20180302_00007.jpg

LM Start	0.69	Rating **	M	Issue No.	17
LM End	0.69	Issue Type +	Ma	Location *	LS
Category	Earthen Levee			GPS Latitude/Longitude	
				Start	End
Item	Animal Control			38.903352 °	38.903352 °
				-121.607829 °	-121.607829 °
DWR ID	DWR_MA0003_01_s_2017_17				
Comment Code					
A1 : Exterminate rodents and backfill and compact or grout burrows.					
Inspector Comment					
A large hole on the lanside that look to be from a large animal needs to be repaired, Fall 2017.

View of the existing animal hole that is on the outside edge of the landside patrol road needs to be repaired. It is outside the levee prism, but should be monitored, Fall 2017.

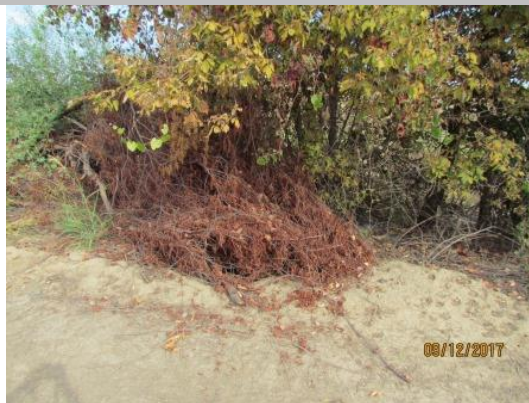
Photo 2 of 3 : SP_2018_MA0003_195_17_20180302_00008.jpg

The existing animal hole that is on the outside edge of the landside patrol road does not appear to have any recent animal activity, Fall 2017.

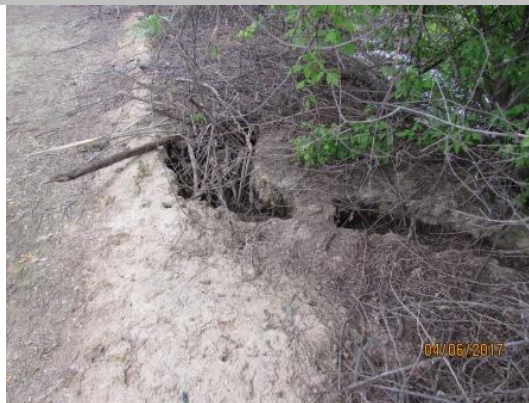
Photo 3 of 3 : SP_2018_MA0003_195_17_20180302_00009.jpg

LM Start	0.69	Rating **	M	Issue No.	17 (cont)	
LM End	0.69	Issue Type +	Ma	Location *	LS	
Category	Earthen Levee			GPS Latitude/Longitude		
				Start		End
Item	Animal Control			38.903352 °		38.903352 °
				-121.607829 °		-121.607829 °
DWR ID	DWR_MA0003_01_s_2017_17					
Comment Code						
A1 : Exterminate rodents and backfill and compact or grout burrows.						
Inspector Comment						
A large hole on the lanside that look to be from a large animal needs to be repaired, Fall 2017.

View of a large hole on the landside that look to be from a large animal, Spring 2017.

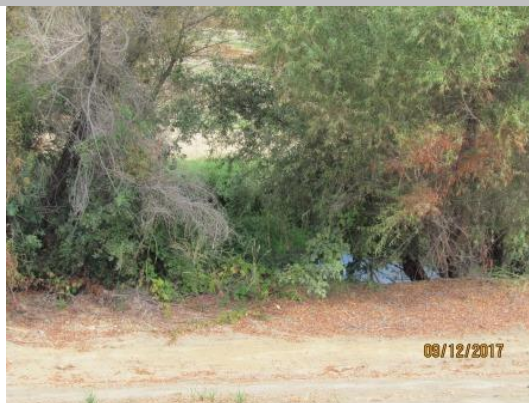
Photo 1 of 2 : SP_2018_MA0003_195_140_20180302_00013.jpg

LM Start	0.78	Rating **	A/W	Issue No.	140
LM End	0.78	Issue Type +	Ma	Location *	LS
Category	Earthen Levee			GPS Latitude/Longitude	
				Start	End
Item	Animal Control			38.903339 °	38.903339 °
				-121.606209 °	-121.606209 °
DWR ID	DWR_MA0003_01_f_2014_140				
Comment Code					
A3 : No rodents visible, but rodent burrows visible; need to backfill and compact or grout burrows.					
Inspector Comment					
The rodent hole on the landward toe road approximately 8" in diameter tis no longer there but should be monitored. Fall 2017.

View of where the rodent hole has been repaired, Fall 2017.

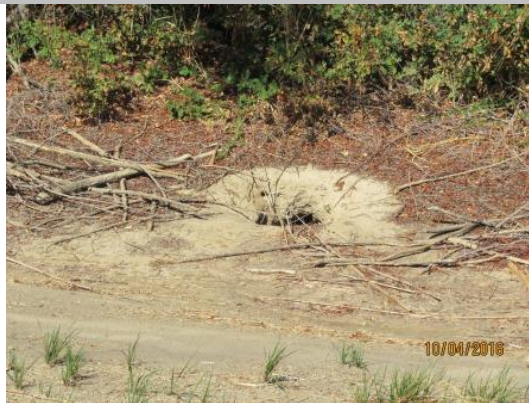
Photo 2 of 2 : SP_2018_MA0003_195_140_20180302_00014.jpg

This photo was taken from the landward levee slope near the toe road facing north looking at an approximately 8" rodent hole. Fall 2016.

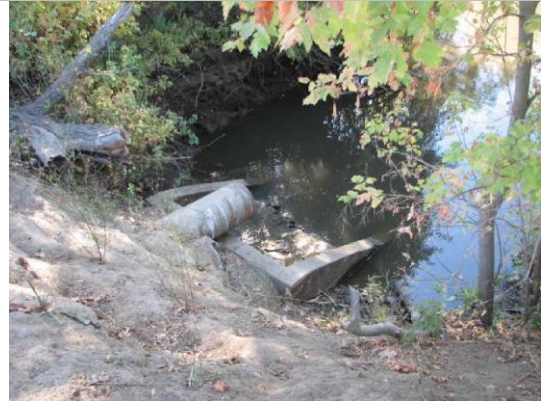
Photo 2 of 3 : UCIP_SP_2018_51474_64648.jpg

FS_ID:51474
DS_ID:17092
EP_NO: N/A
Repair Type: Urgent
Crossing Status: Found
UCIP Comments: 4/11/2017 Water levels were high on WS during inspection so pipe ends could not be inspected. Believe that the sandbags are still in place and condition of flap gates is unknown. (DWR Sutter Yard - afreitag)10/10/2016 WS pipe end was underwater for inspection but the sandbags still appear to be in place. (DWR Sutter Yard - afreitag)4/18/2016 No repairs have been made to the pipe yet. (DWR Sutter Yard - afreitag)5/12/2015 Water level high in WS ditch so could not see WS end of crossing. Do not believe that repairs have been made yet. (DWR Sutter Yard - afreitag)11/17/2014 Same as last inspection. (DWR Sutter Yard - afreitag)5/14/2014 Same as last inspection. (DWR Sutter Yard - afreitag)10/30/2013 Same as last inspection. (DWR Sutter Yard - afreitag)5/21/2013 SBFCA project recommends replacing in accordance with title 23. High water levels in WS ditch have pipe ends underwater but repairs have not yet been completed but are planned for when water levels drop. (DWR Sutter Yard - afreitag)10/10/2012 Flap gates not visible on waterward headwall and it appears as though they have been replaced by sandbags. Slide gates on LS appear to be closed yet water leaks excessively from the WS at the sandbagged headwall. (DWR UCIP - wwwylie)

Concrete U shaped headwall on WS toe filled in with Sandbags. 16-inch pipe shown over top of headwall.

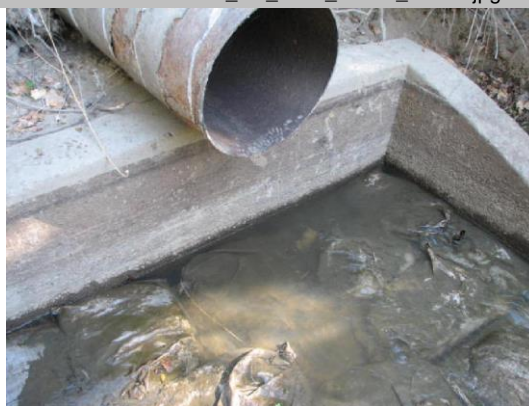
Photo 3 of 3 : UCIP_SP_2018_51474_64647.jpg

FS_ID:51474
DS_ID:17092
EP_NO: N/A
Repair Type: Urgent
Crossing Status: Found
UCIP Comments: 4/11/2017 Water levels were high on WS during inspection so pipe ends could not be inspected. Believe that the sandbags are still in place and condition of flap gates is unknown. (DWR Sutter Yard - afreitag)10/10/2016 WS pipe end was underwater for inspection but the sandbags still appear to be in place. (DWR Sutter Yard - afreitag)4/18/2016 No repairs have been made to the pipe yet. (DWR Sutter Yard - afreitag)5/12/2015 Water level high in WS ditch so could not see WS end of crossing. Do not believe that repairs have been made yet. (DWR Sutter Yard - afreitag)11/17/2014 Same as last inspection. (DWR Sutter Yard - afreitag)5/14/2014 Same as last inspection. (DWR Sutter Yard - afreitag)10/30/2013 Same as last inspection. (DWR Sutter Yard - afreitag)5/21/2013 SBFCA project recommends replacing in accordance with title 23. High water levels in WS ditch have pipe ends underwater but repairs have not yet been completed but are planned for when water levels drop. (DWR Sutter Yard - afreitag)10/10/2012 Flap gates not visible on waterward headwall and it appears as though they have been replaced by sandbags. Slide gates on LS appear to be closed yet water leaks excessively from the WS at the sandbagged headwall. (DWR UCIP - wwwylie)

Concrete U shaped headwall filled in with sandbags on WS toe. Flap gates appear to be missing and water readily flows through the sandbags from LS.

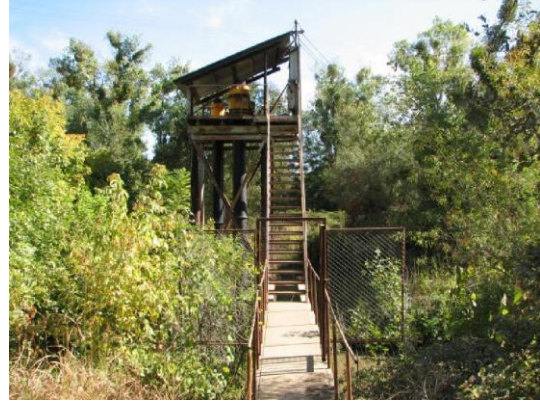
Photo 3 of 3 : UCIP_SP_2018_51477_64666.jpg

FS_ID:51477
DS_ID:17088
EP_NO: 3284
Repair Type: Urgent
Crossing Status: Found
UCIP Comments: 4/11/2017 There was a cavity collapse above the pipe alignment on the WS slope during January 2017 high water event. Cavity was filled with rock to prevent further levee damage during the high water season. Further inspection will be needed on this crossing to determine the cause of the collapse. Recommend having an internal camera inspection done. Erosion happening around the WS concrete vault. (DWR Sutter Yard- AFreitag)10/10/2016 LS pipe end was mostly submerged so could not verify the connectivity between the LS headwall and WS vault. B Lackberries and still overgrown on WS.(DWR Sutter Yard - afreitag)4/18/2016 WS vault is being overgrown with blackberries. They should be sprayed and cleared back. No other problems were noticeable with this crossing.5/12/2015 Only the right flapgate appeared to be abandoned. The left and middle flap gates were flowing water during the last inspection.11/17/2014 Same as last inspection.5/14/2014 Same as last inspection.10/30/2013 Same as last inspection.5/21/2013 Pumping plant was running and filling concrete vault on WS toe through the left flap gate and then flowing through levee pipe and filling irrigation ditch on LS. Left and middle flap gates appear to be connected to pumps and right gate appears abandoned. Recommend contacting owner to get more details.10/10/2012 Pumping plant has been disconnected from levee. Need to determine if abandonment is appropriate or if this is now a gravity drain with flap gate.

Pumping plant on WS toe at small slough. Pipes no longer connected to concrete box on WS toe.

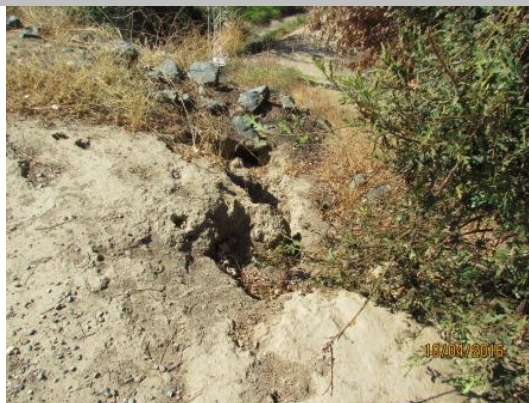
Photo 1 of 1 : SP_2018_MA0003_195_18_20180302_00010.jpg

LM Start	2.18	Rating **	A/W	Issue No.	18
LM End	2.18	Issue Type +	Ma	Location *	LS
Category	Earthen Levee			GPS Latitude/Longitude	
				Start	End
Item	Animal Control			38.911869 °	38.911869 °
				-121.586093 °	-121.586093 °
DWR ID	DWR_MA0003_01_s _ 2015_18				
Comment Code					
A3 : No rodents visible, but rodent burrows visible; need to backfill and compact or grout burrows.					
Inspector Comment					
No animal activity, Fall 2017.

View of rodent holes that need to be backfilled, No evidence of rodents during inspection. Fall 2016.

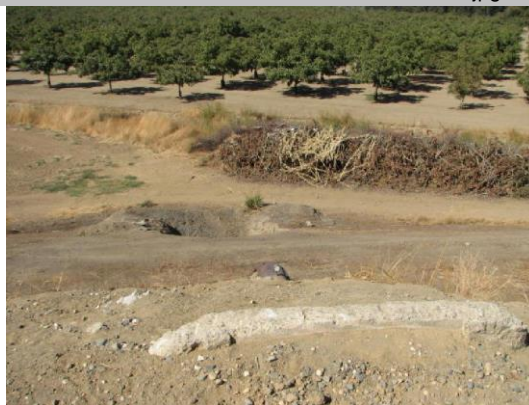
Photo 2 of 3 : UCIP_SP_2018_51481_64671.jpg

FS_ID:51481
DS_ID:17087
EP_NO: 1730
Repair Type: Non-Urgent
Crossing Status: Found
UCIP Comments: 4/11/2017 Big dig out/depression still present at the LS toe. Pipe is set to be replaced during the SBFCA project so depression should be repaired then. (DWR Sutter Yard - AFreitag)10/10/2016 Depression is still present at the LS toe but appears that it was dug out on purpose.(DWR Sutter Yard - afreitag)4/18/2016 Big depression on LS toe along the pipe alignment. 5/12/2015 Crossing appears to be in good condition. No noticeable issues to report.11/17/2014 Same as last inspection.5/14/2014 Same as last inspection.10/30/2013 Same as last inspection.5/21/2013 SBFCA project recommends replacing in accordance with title 23. Same as last inspection.
FIELD_STRUCT_DESC: 12-inch asphalt coated steel irrigation pipe through the levee, 4.5 feet below the crown. Gate valve and pump located on the waterside (WS). 24-inch concrete standpipe located on the landside (LS) toe has been degraded to ground elevation and filled in with soil. Pipe remains intact. Steel tower over pump is located on the WS. (Permit No. 1730, 1959 - Robert L. Crandall). [Additional Reference(s): DWR Levee Log, 2005].

Pipe at LS shoulder showing exposed concrete cutoff wall.

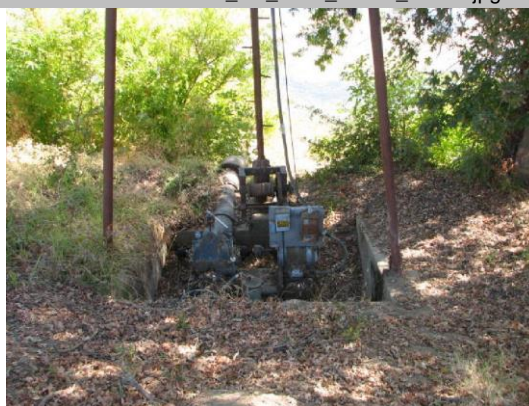
Photo 3 of 3 : UCIP_SP_2018_51481_64670.jpg

Comment Code						
Inspector Comment						
FS_ID:51481 DS_ID:17087 EP_NO: 1730 Repair Type: Non-Urgent Crossing Status: Found UCIP Comments: 4/11/2017 Big dig out/depression still present at the LS toe. Pipe is set to be replaced during the SBFCA project so depression should be repaired then. (DWR Sutter Yard-AFreitag)10/10/2016 Depression is still present at the LS toe but appears that it was dug out on purpose.(DWR Sutter Yard -afreitag)4/18/2016 Big depression on LS toe along the pipe alignment. 5/12/2015 Crossing appears to be in good condition. No noticeable issues to report.11/17/2014 Same as last inspection.5/14/2014 Same as last inspection.10/30/2013 Same as last inspection.5/21/2013 SBFCA project recommends replacing in accordance with title 23. Same as last inspection. FIELD_STRUCT_DESC: 12-inch asphalt coated steel irrigation pipe through the levee, 4.5 feet below the crown. Gate valve and pump located on the waterside (WS). 24-inch concrete standpipe located on the landside (LS) toe has been degraded to ground elevation and filled in with soil. Pipe remains intact. Steel tower over pump is located on the WS. (Permit No. 1730, 1959 - Robert L. Crandall). [Additional Reference(s): DWR Levee Log, 2005]. FS Date: 4/12/2017 9:16:41 AM

Pump at WS toe with tower over top and concrete U shaped headwall.

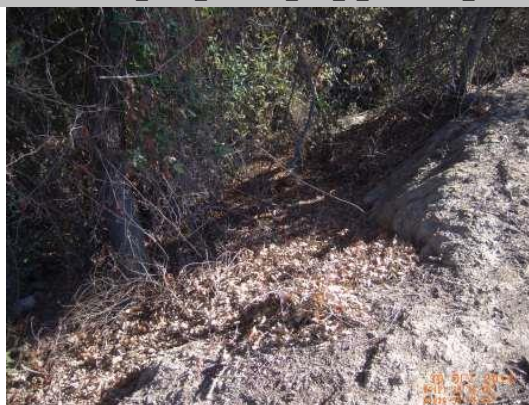
Photo 1 of 2 : SP_2018_MA0003_195_1_20180302_00001.jpg

LM Start	4.15	Rating **	M	Issue No.	1
LM End	4.18	Issue Type +	Ma	Location *	WS
Category	Supplemental			GPS Latitude/Longitude	
				Start	End
Item	2015 USACE Erosion Survey, DRAFT			38.937451 °	38.937937 °
				-121.588512 °	-121.588471 °
DWR ID	DWR_MA0003_01_s_2016_1				
Comment Code					
Inspector Comment					
2013 - Minor toe scour causing gradual erosion of bank slope. Site is within ecological reserve. 2015: Last observed in 2013. [2015 Site ID: FHR_12-3_R]
